Special Report 77-33
October 1977

LAND TREATMENT OF WASTEWATER at West Dover, Vermont

John R. Bouzoun
AD A 046300

CORPS OF ENGINEERS, U.S. ARMY
COLD REGIONS RESEARCH AND ENGINEERING LABORATORY
HANOVER, NEW HAMPSHIRE

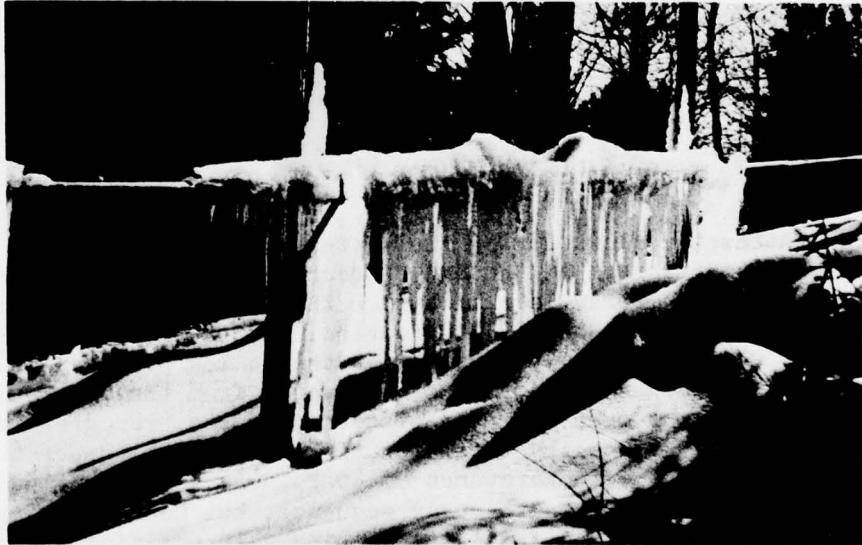
The original high-point nozzles were found to be susceptible to freezing damage. The water in the pipe froze and required excessive maintenance probably due to the non-moving parts. Also, the Buckner spray diameter was significantly larger than the corridor cleared for each lateral, which may have resulted in excessive ice damage to the vegetation. Full Jet 1/4 HH14W nozzles, placed at 25-ft intervals, were selected for winter use to replace the original high-point nozzles. The Full Jet 1/4 HH14W high point nozzles sit flush on the laterals. Freezing spray forms a large cradle of ice on the laterals (see Figure 5) that the operator routinely removes to prevent damage to them.

In April 1976 the engineer recommended that alternating between spray lines not be practiced during the winter months⁸. Therefore, the spray system was operated in that manner starting in October 1976 and through the winter. Now, based on additional experience, the engineer feels that winter operation on a sequencing basis should be attempted using a low end temperature limitation¹. Operating experience indicates that spraying may be conducted as long as the ambient air temperature is 10°F or above¹.

Figure 5. Ice buildup on spray laterals.

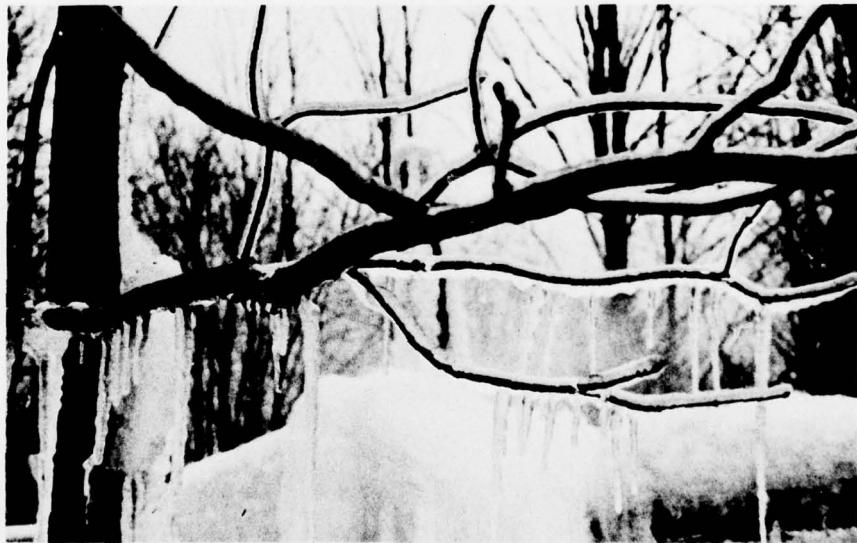
The results of spraying in sub-freezing weather near trees are readily visible. The spray freezes to the lower branches of conifers and young hardwoods and blankets other vegetation with an ice covering (Figure C1). The long-term effects of this ice covering on the vegetation are not known.

Figure C1. Ice accumulation on vegetation at the West Dover land treatment plant.
